## Systematic approach to preservation of wooden architecture monuments

Petrozavodsk. Russia. September 2016

Minimal intervention and application of technology based on use of wood  
to repair and strengthening of wooden architecture monuments

GPAC Built Heritage Research Group  
landa-ochandiano arquitectos  
Mikel Landa  
Alazne Ochandiano

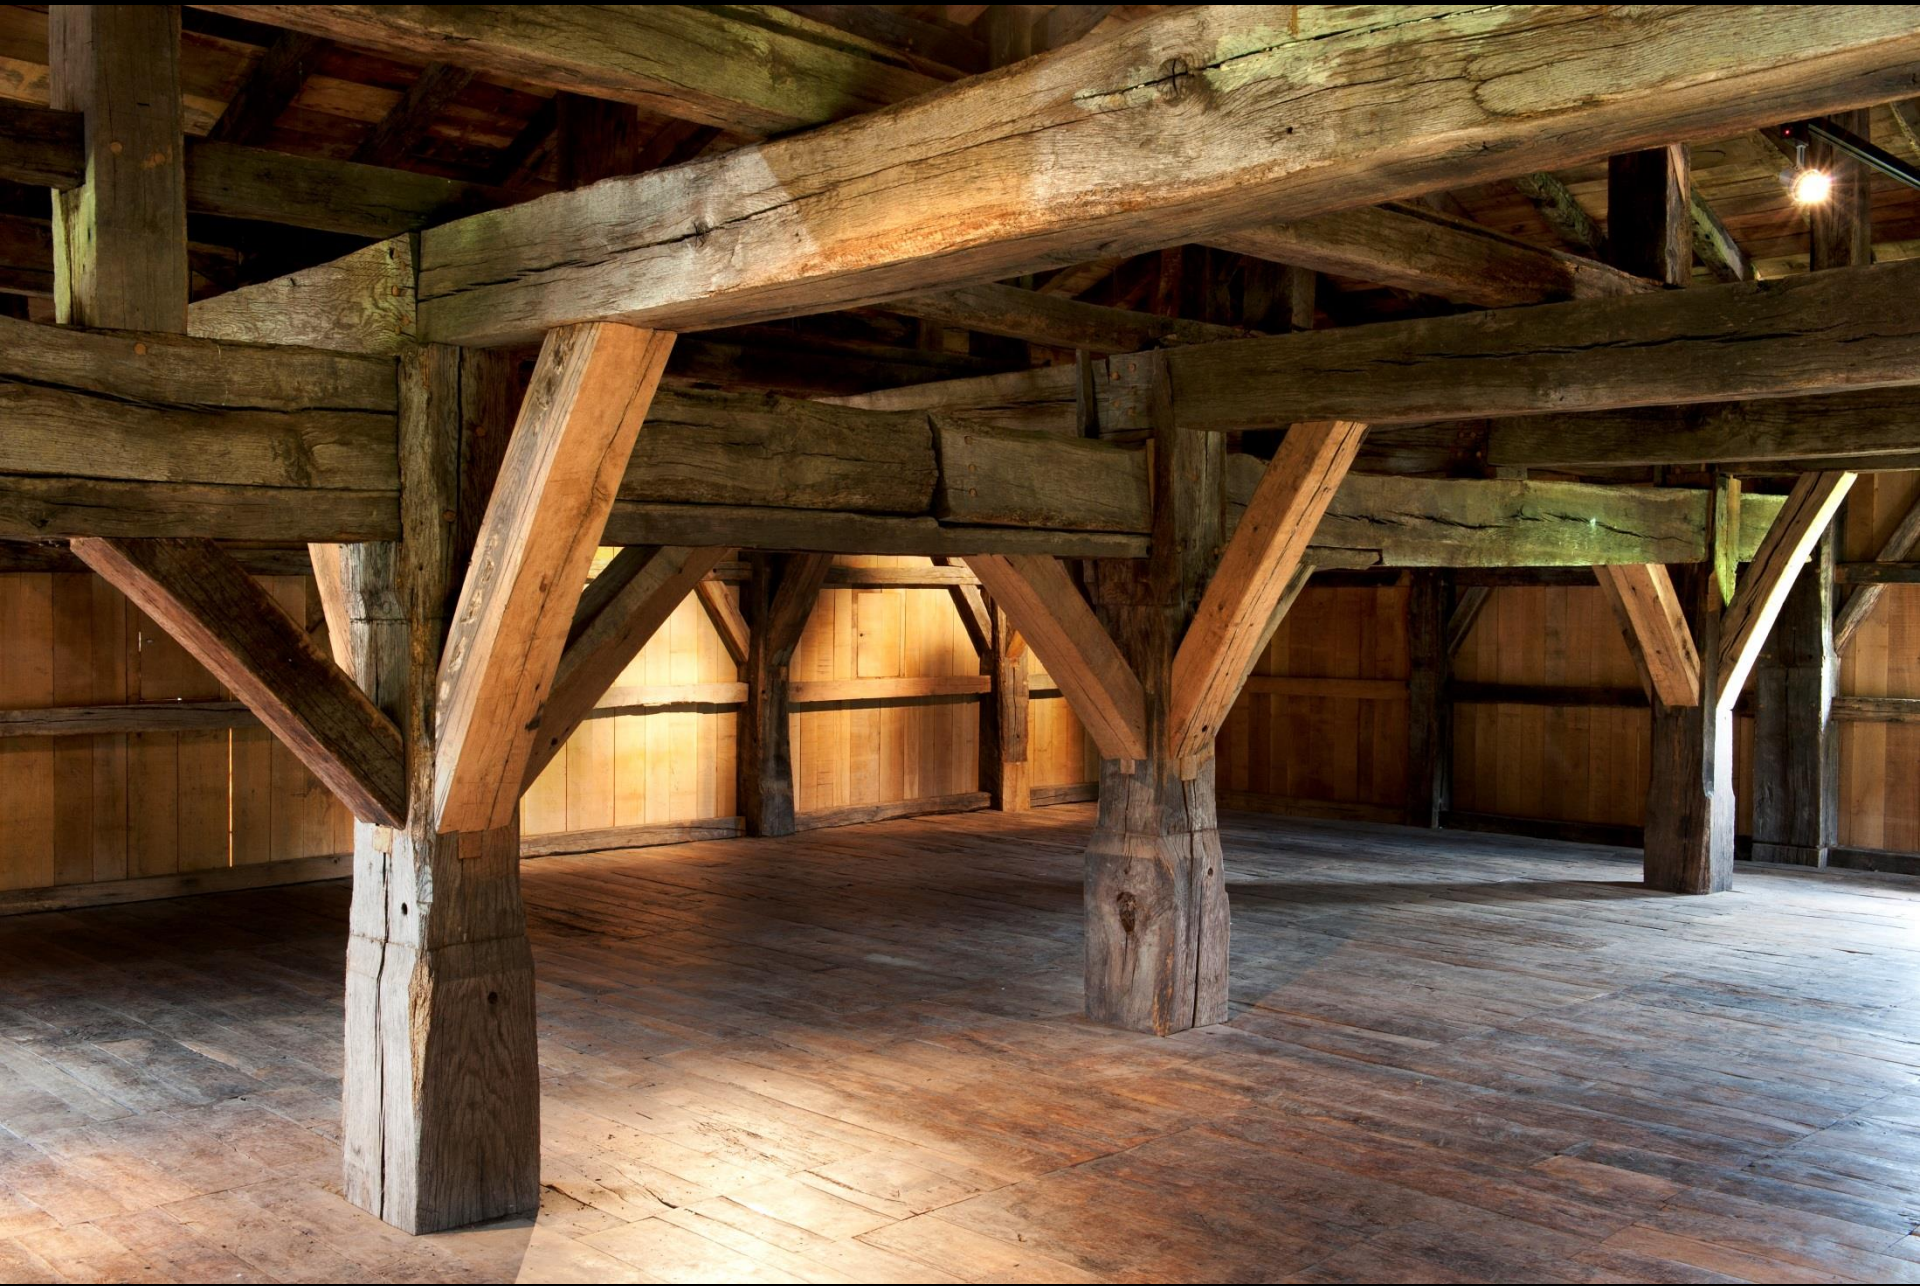
Medieval tower in Donamaría. Navarra

Deformations

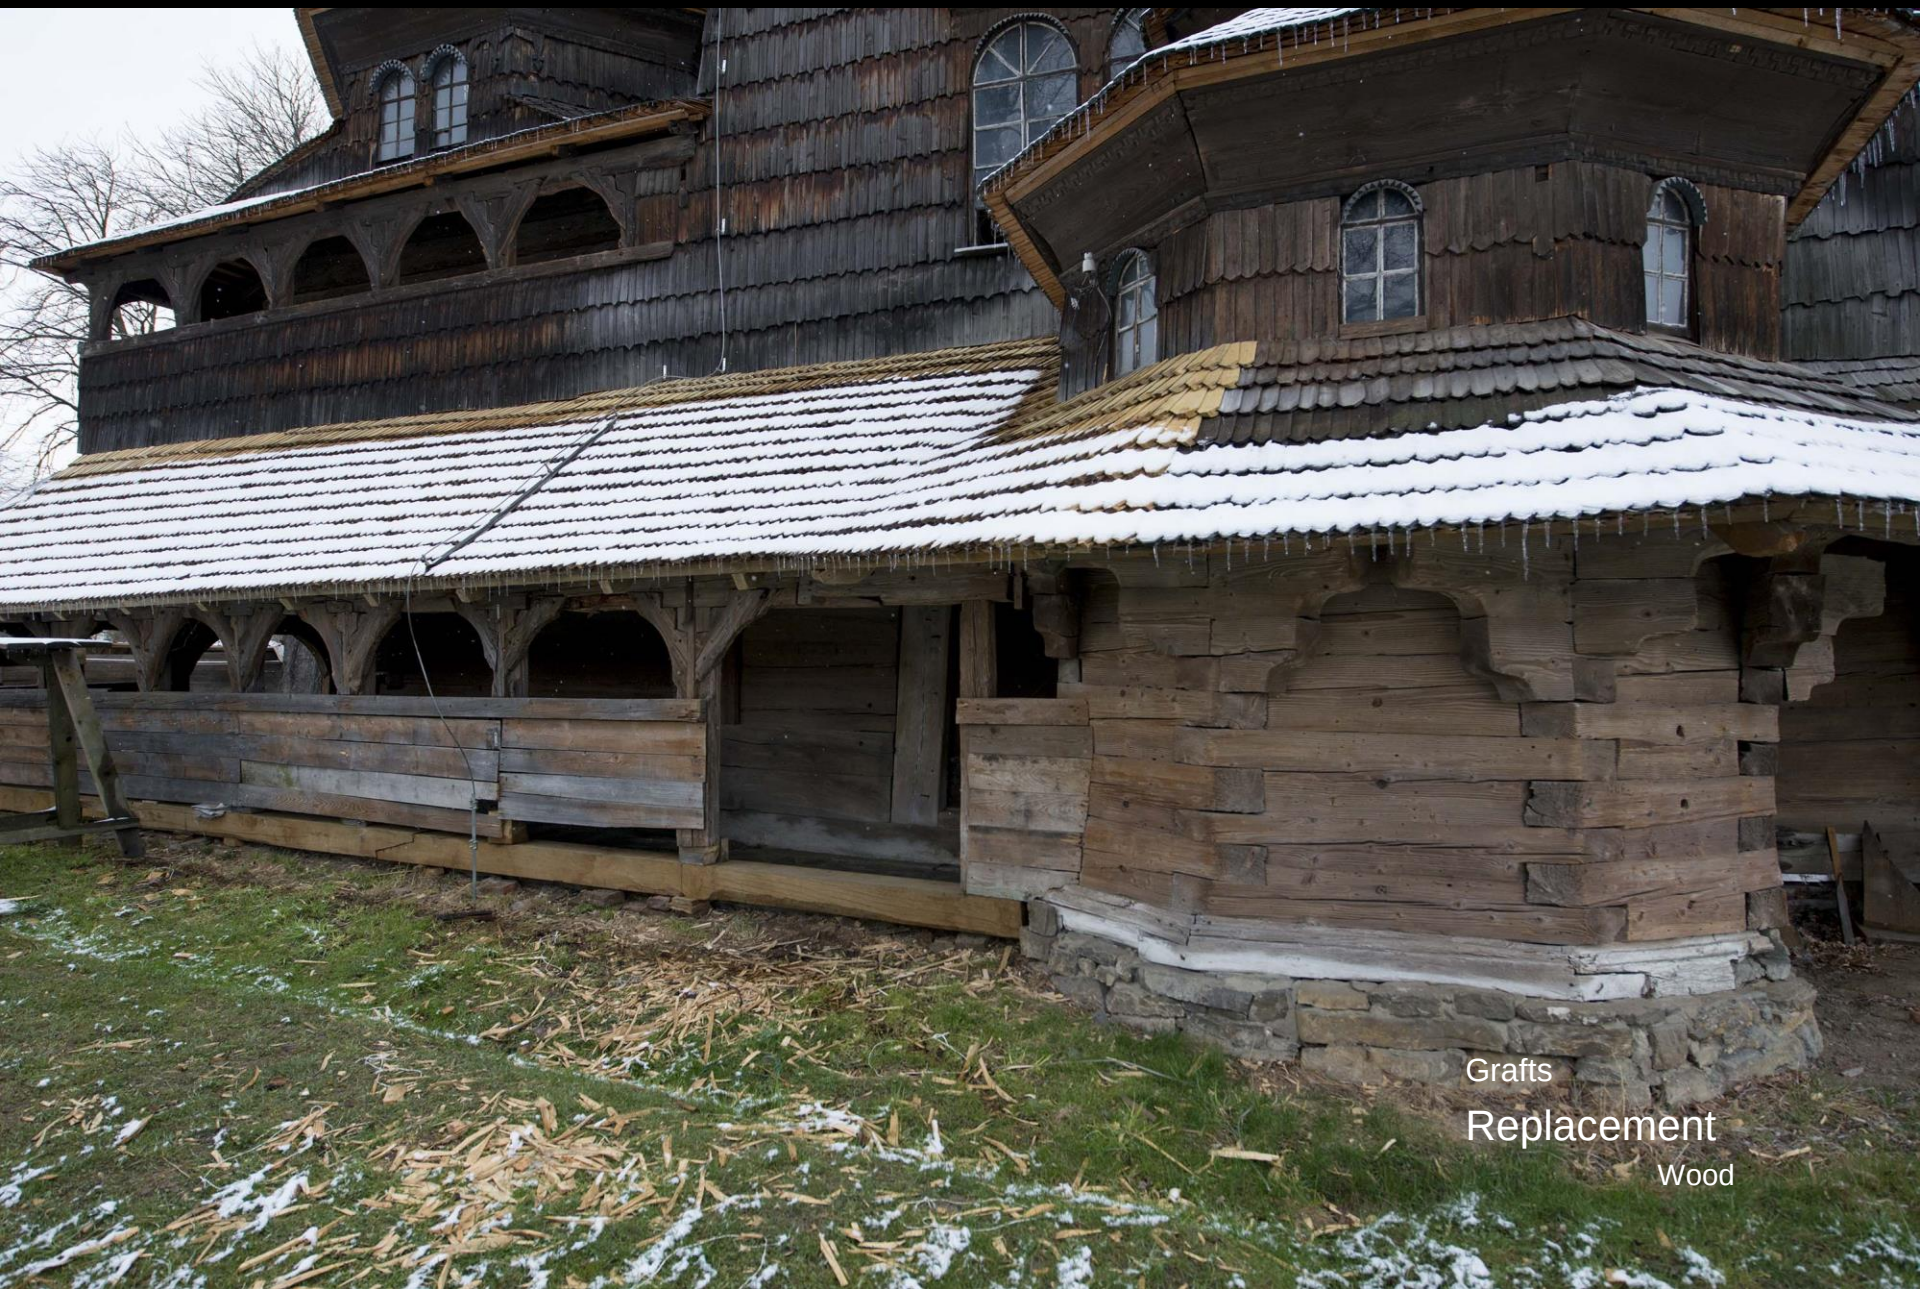
Grafts  
Replacement  
Wood

St. Yuriy church. Drohobych. Ukraine

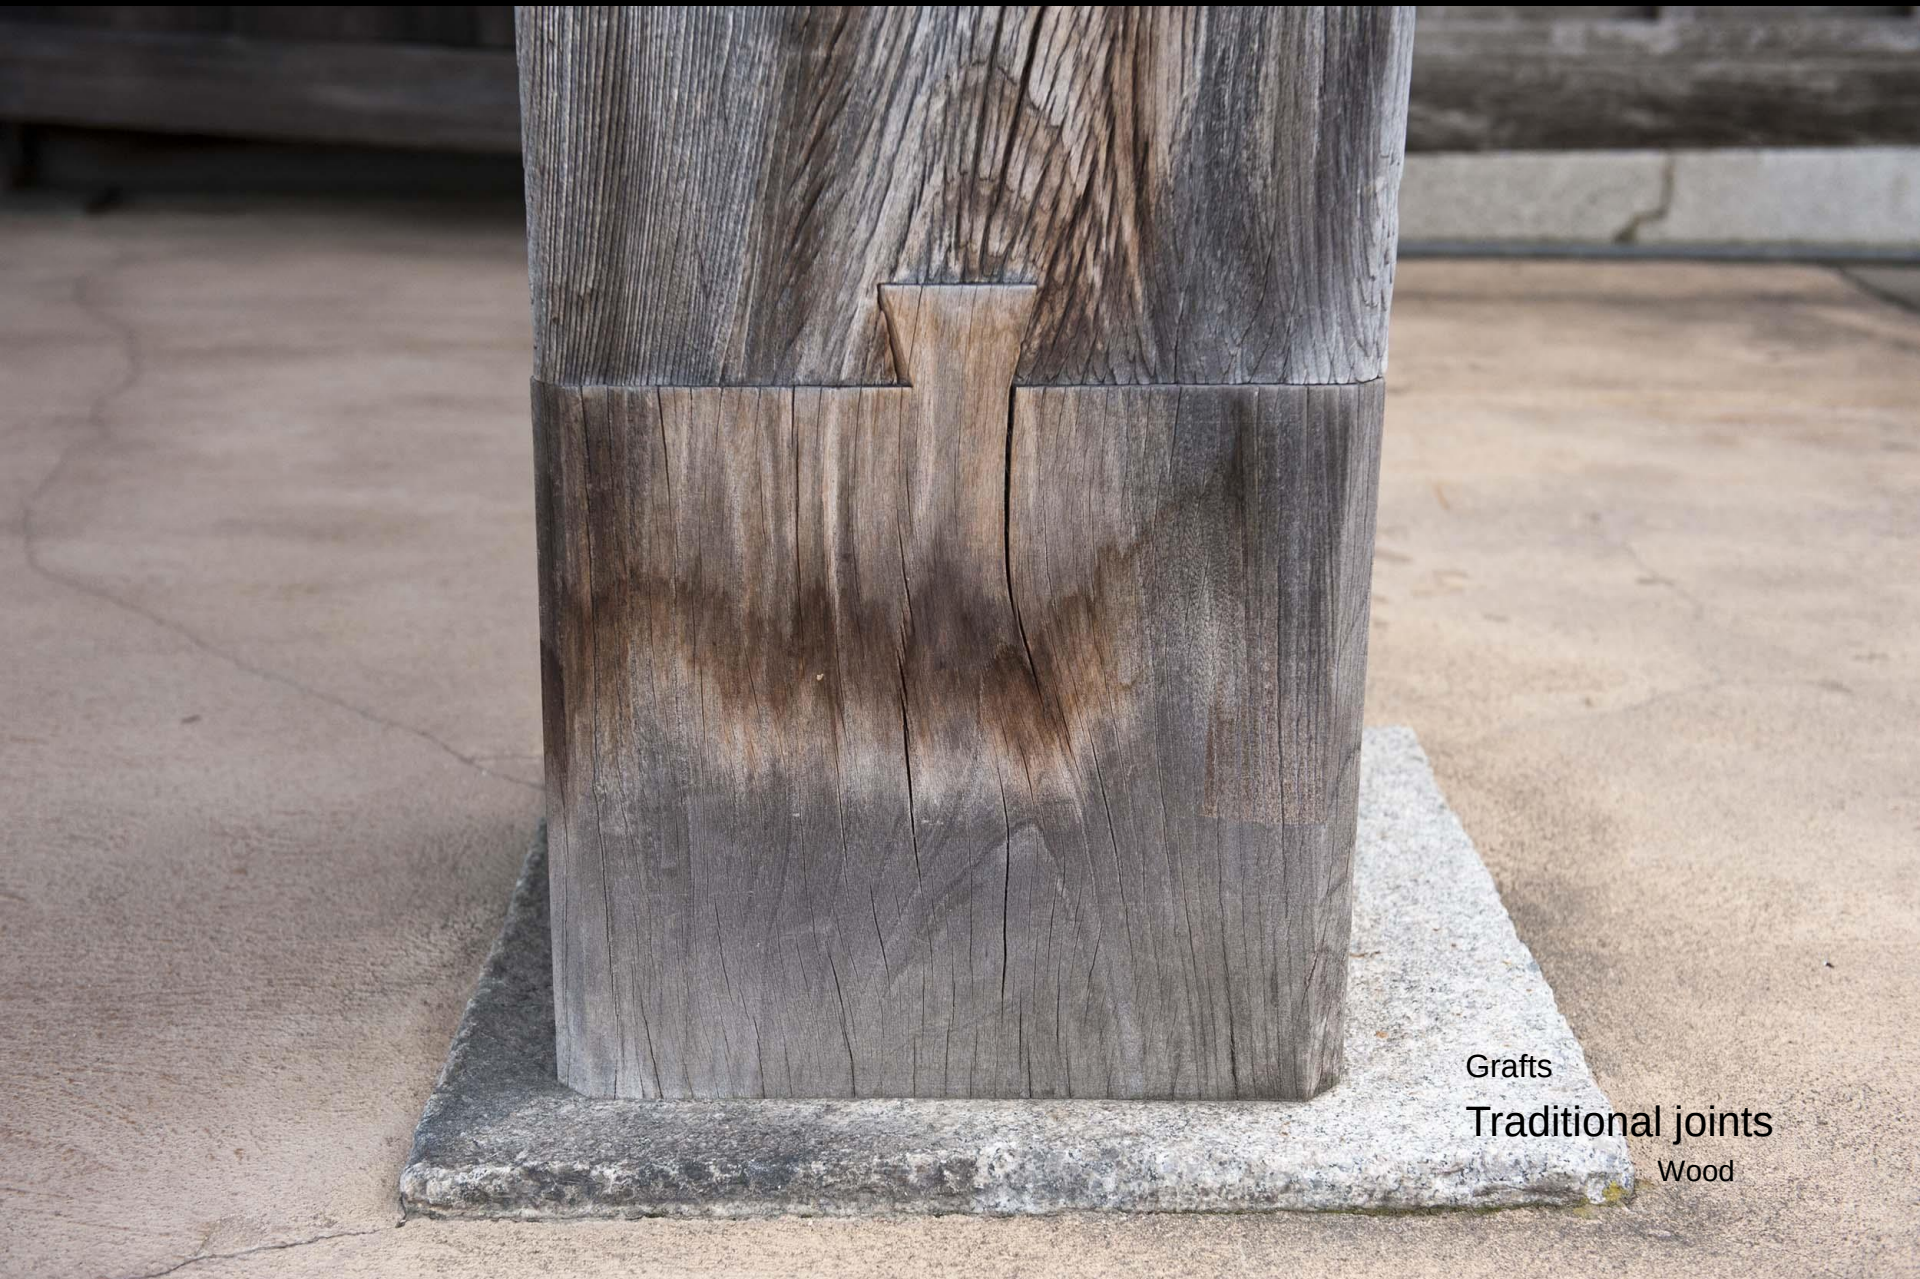
Grafts  
Traditional joints  
Wood

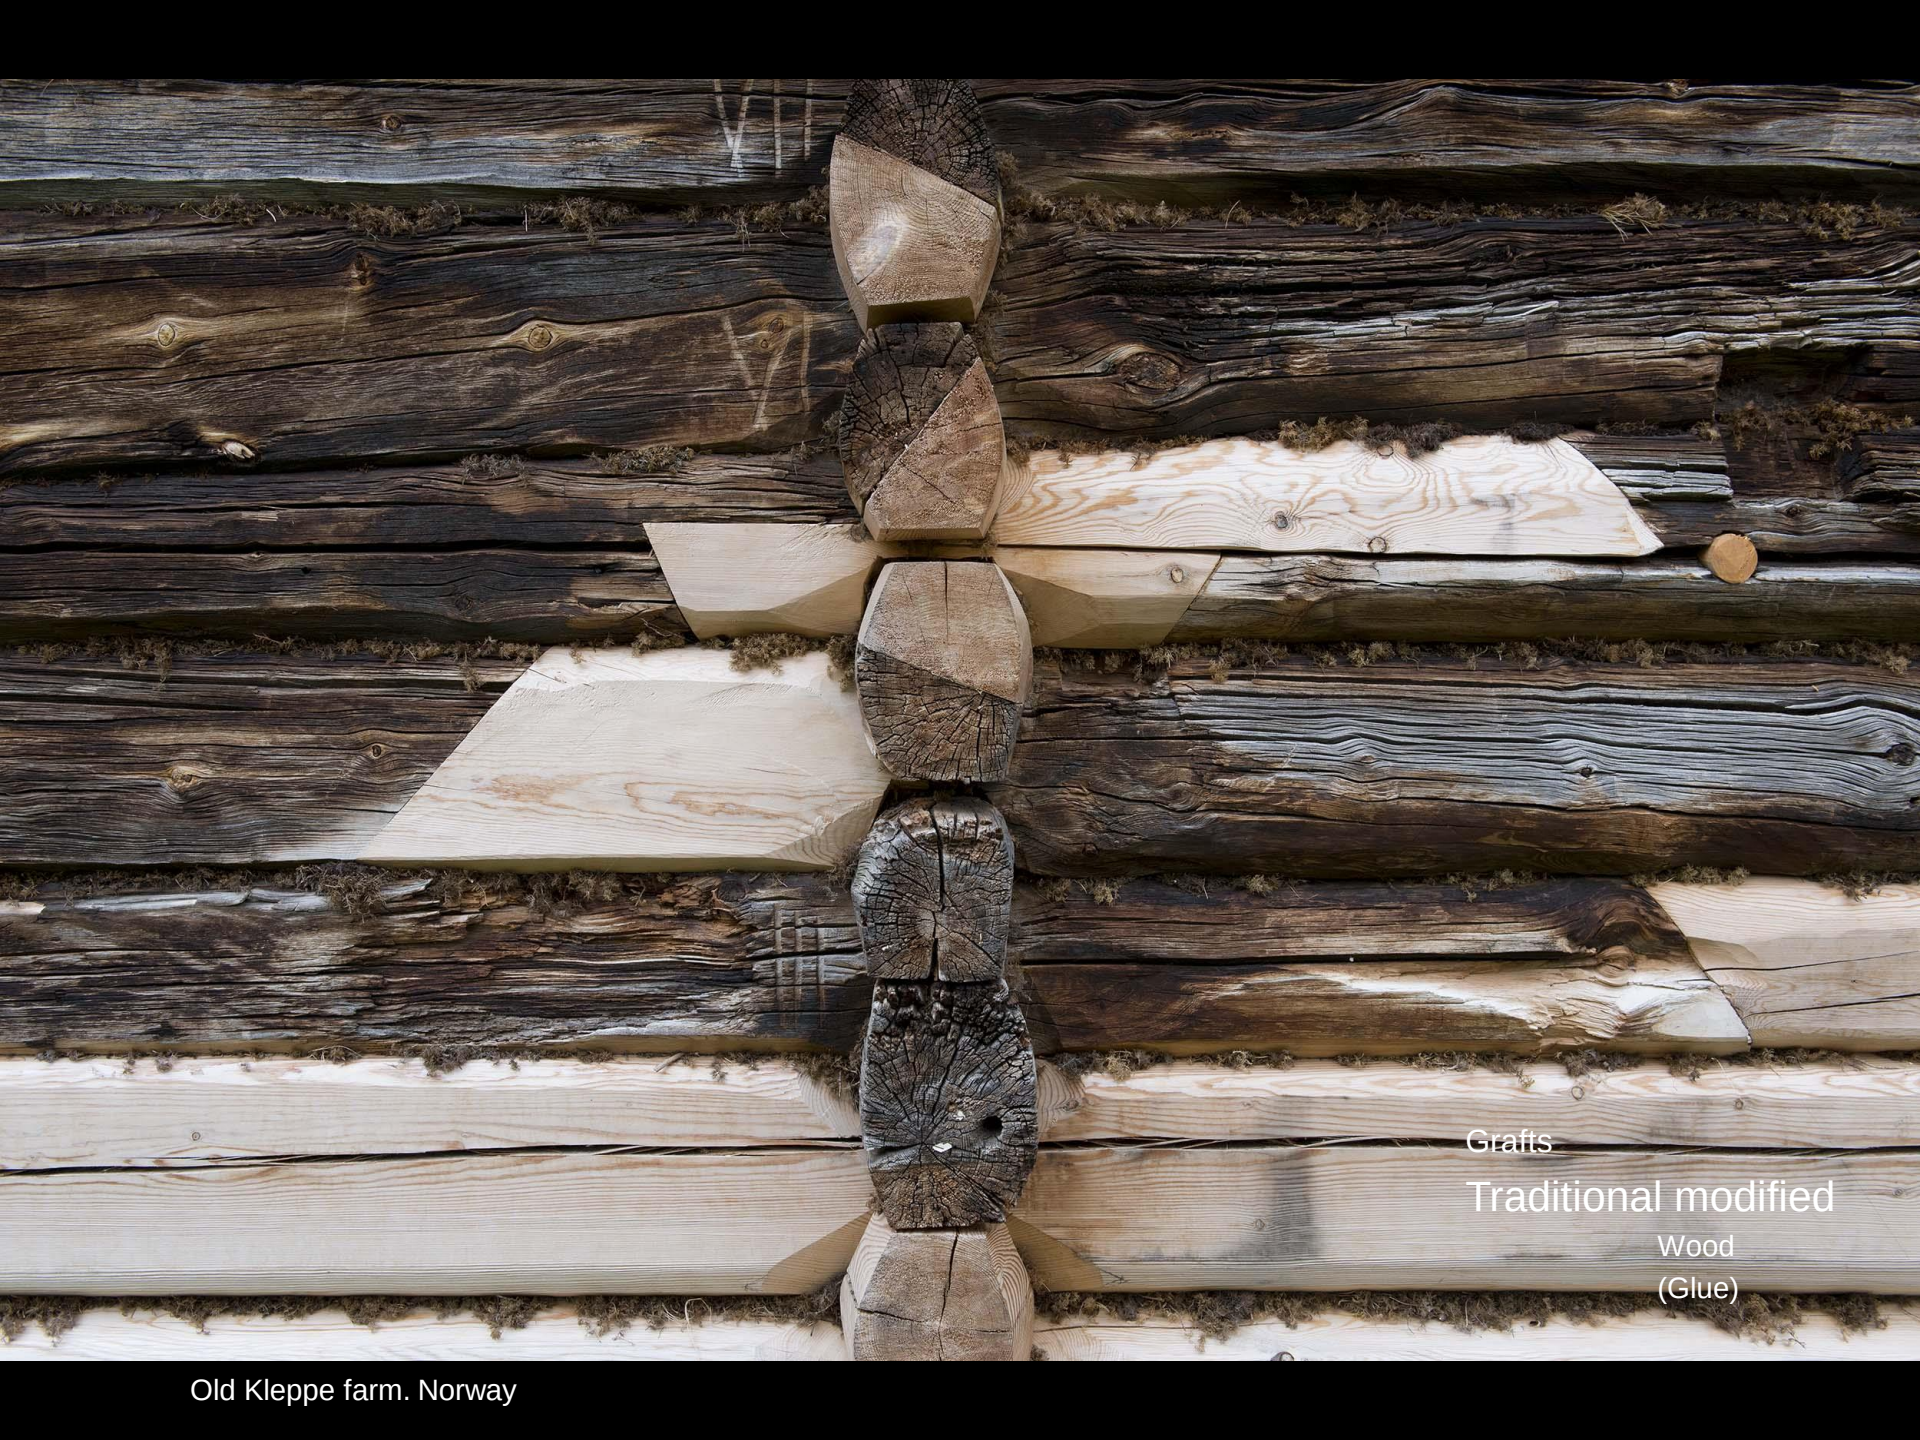
Grafts  
Traditional modified  
Wood  
(Glue)

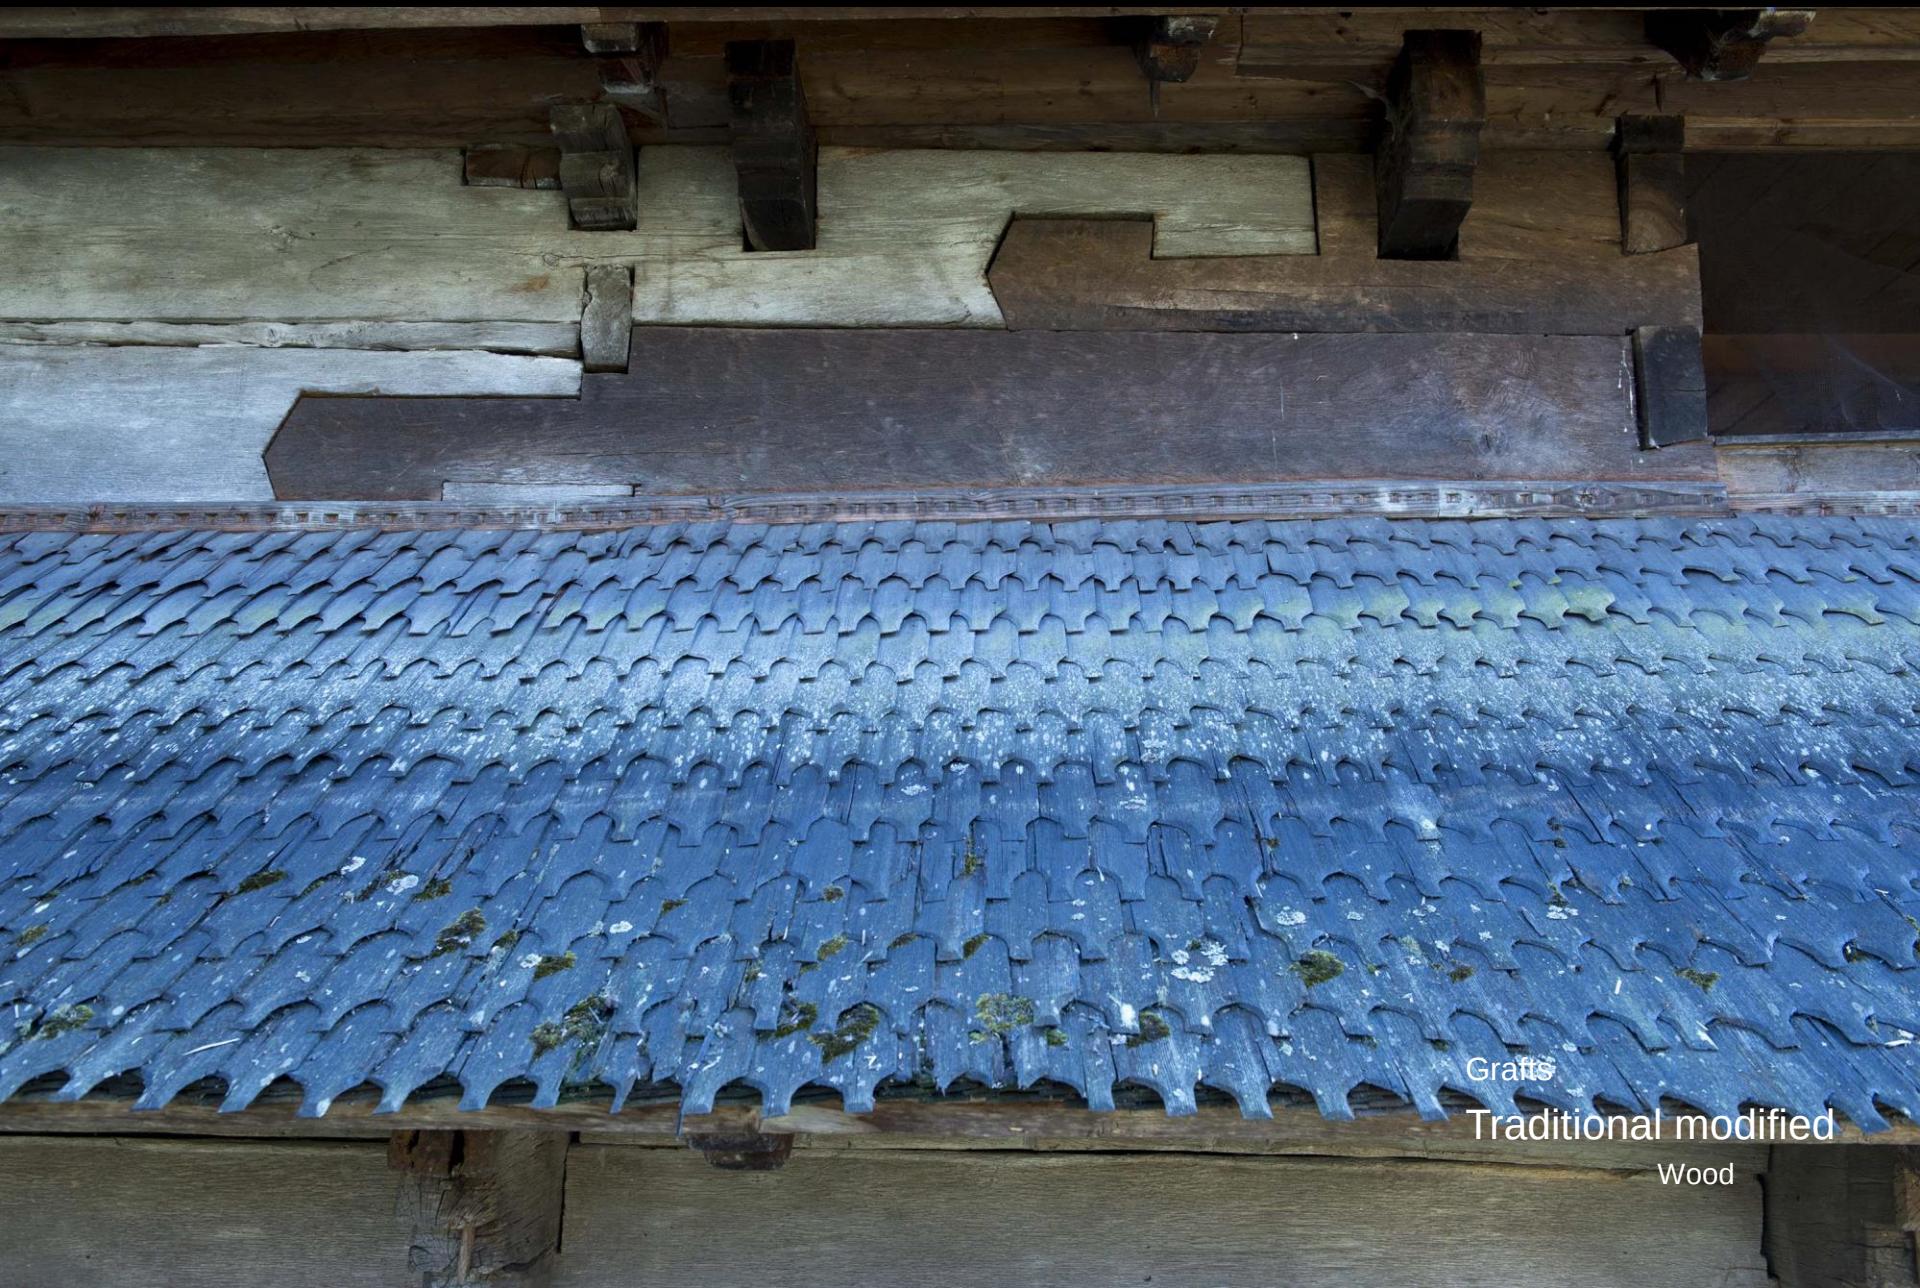
Grafts  
Traditional modified  
Wood

Church of the Presentation of the Virgin in the Temple. Barsana. Maramures. Romania

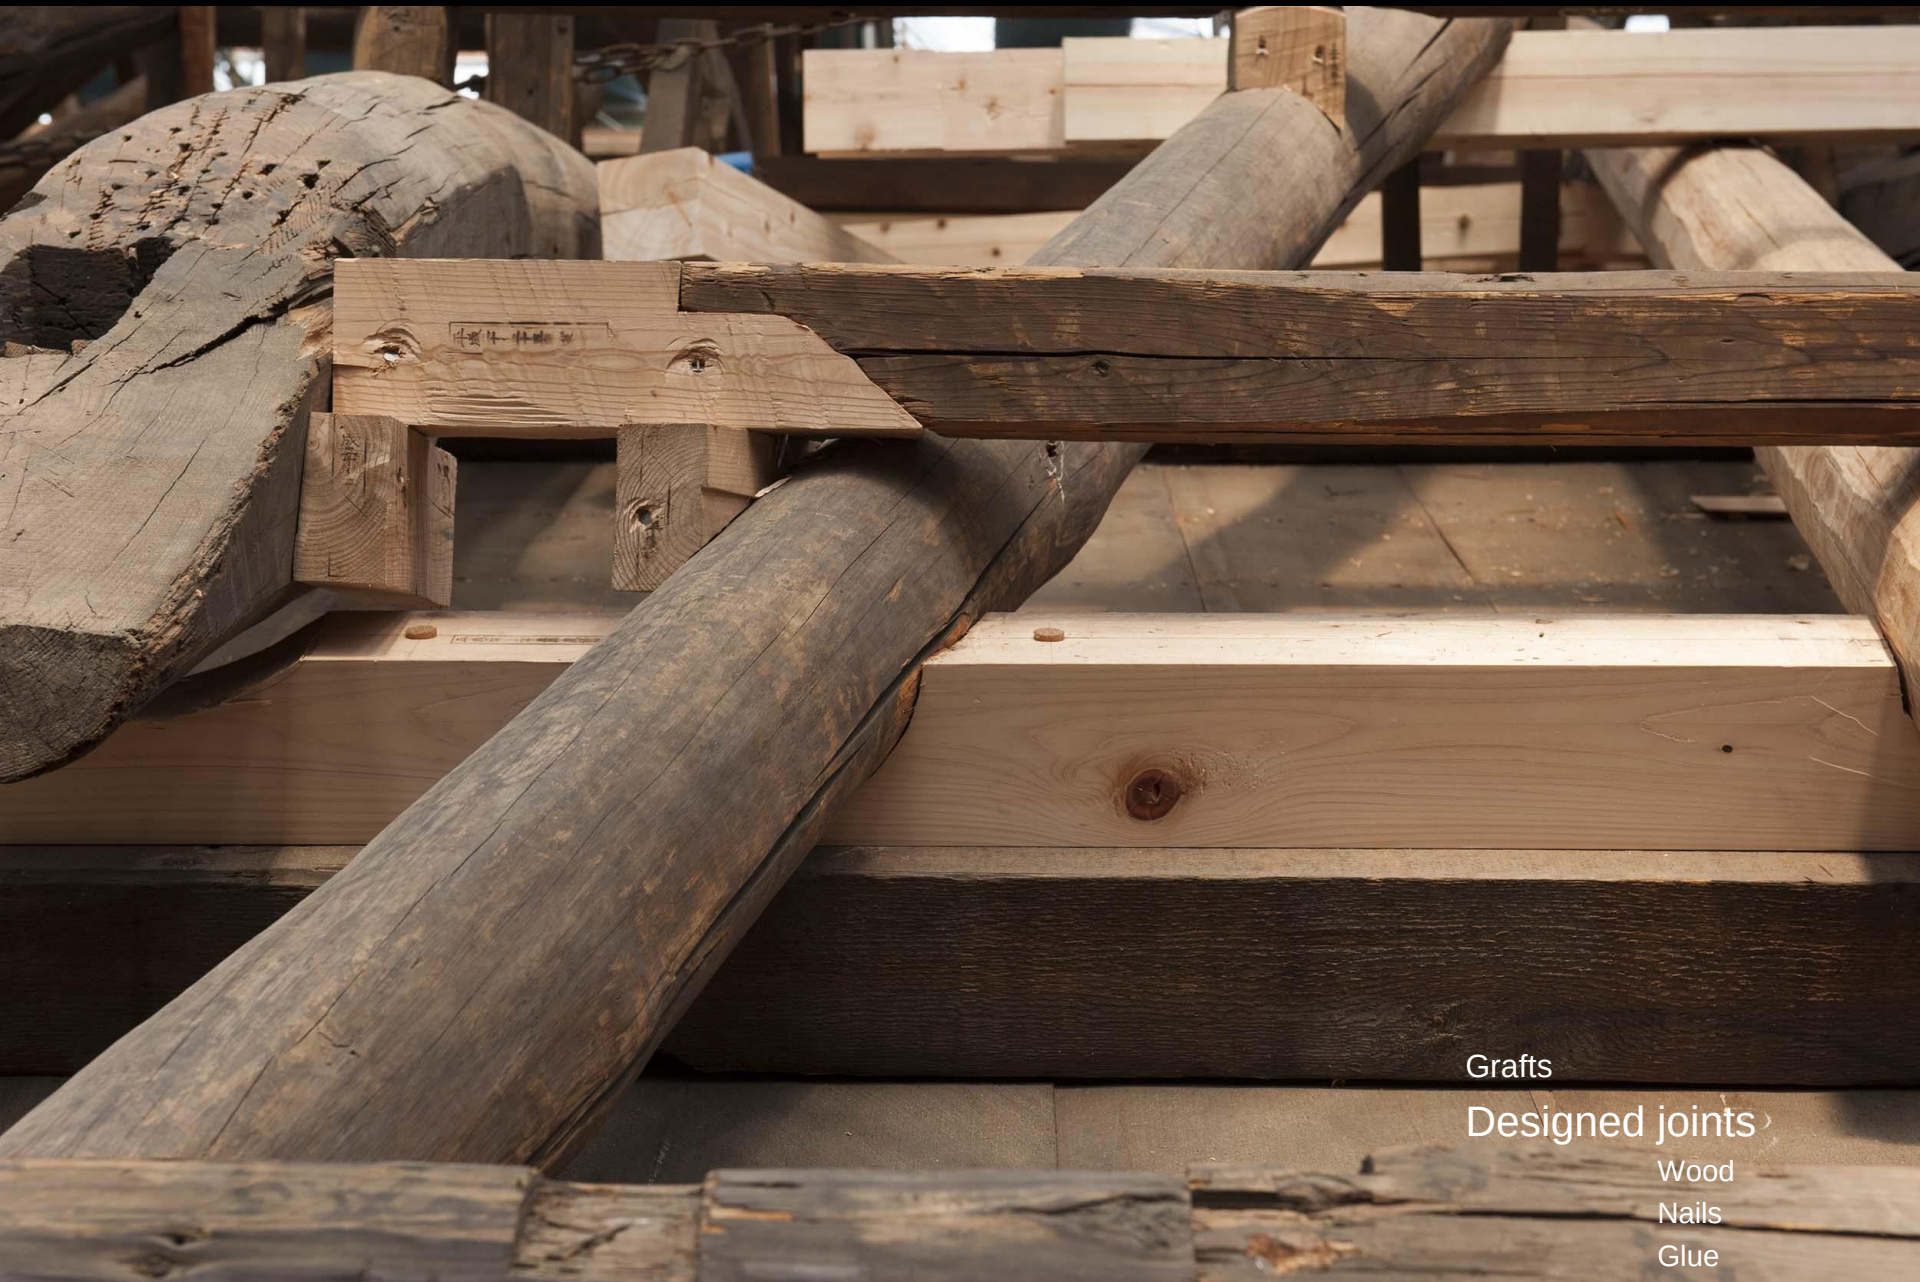
Grafts

Designed joints

Wood

Nails

Glue

Repair of a joist. Gekko-den pavillion. Gokoku-ji temple. Tokyo

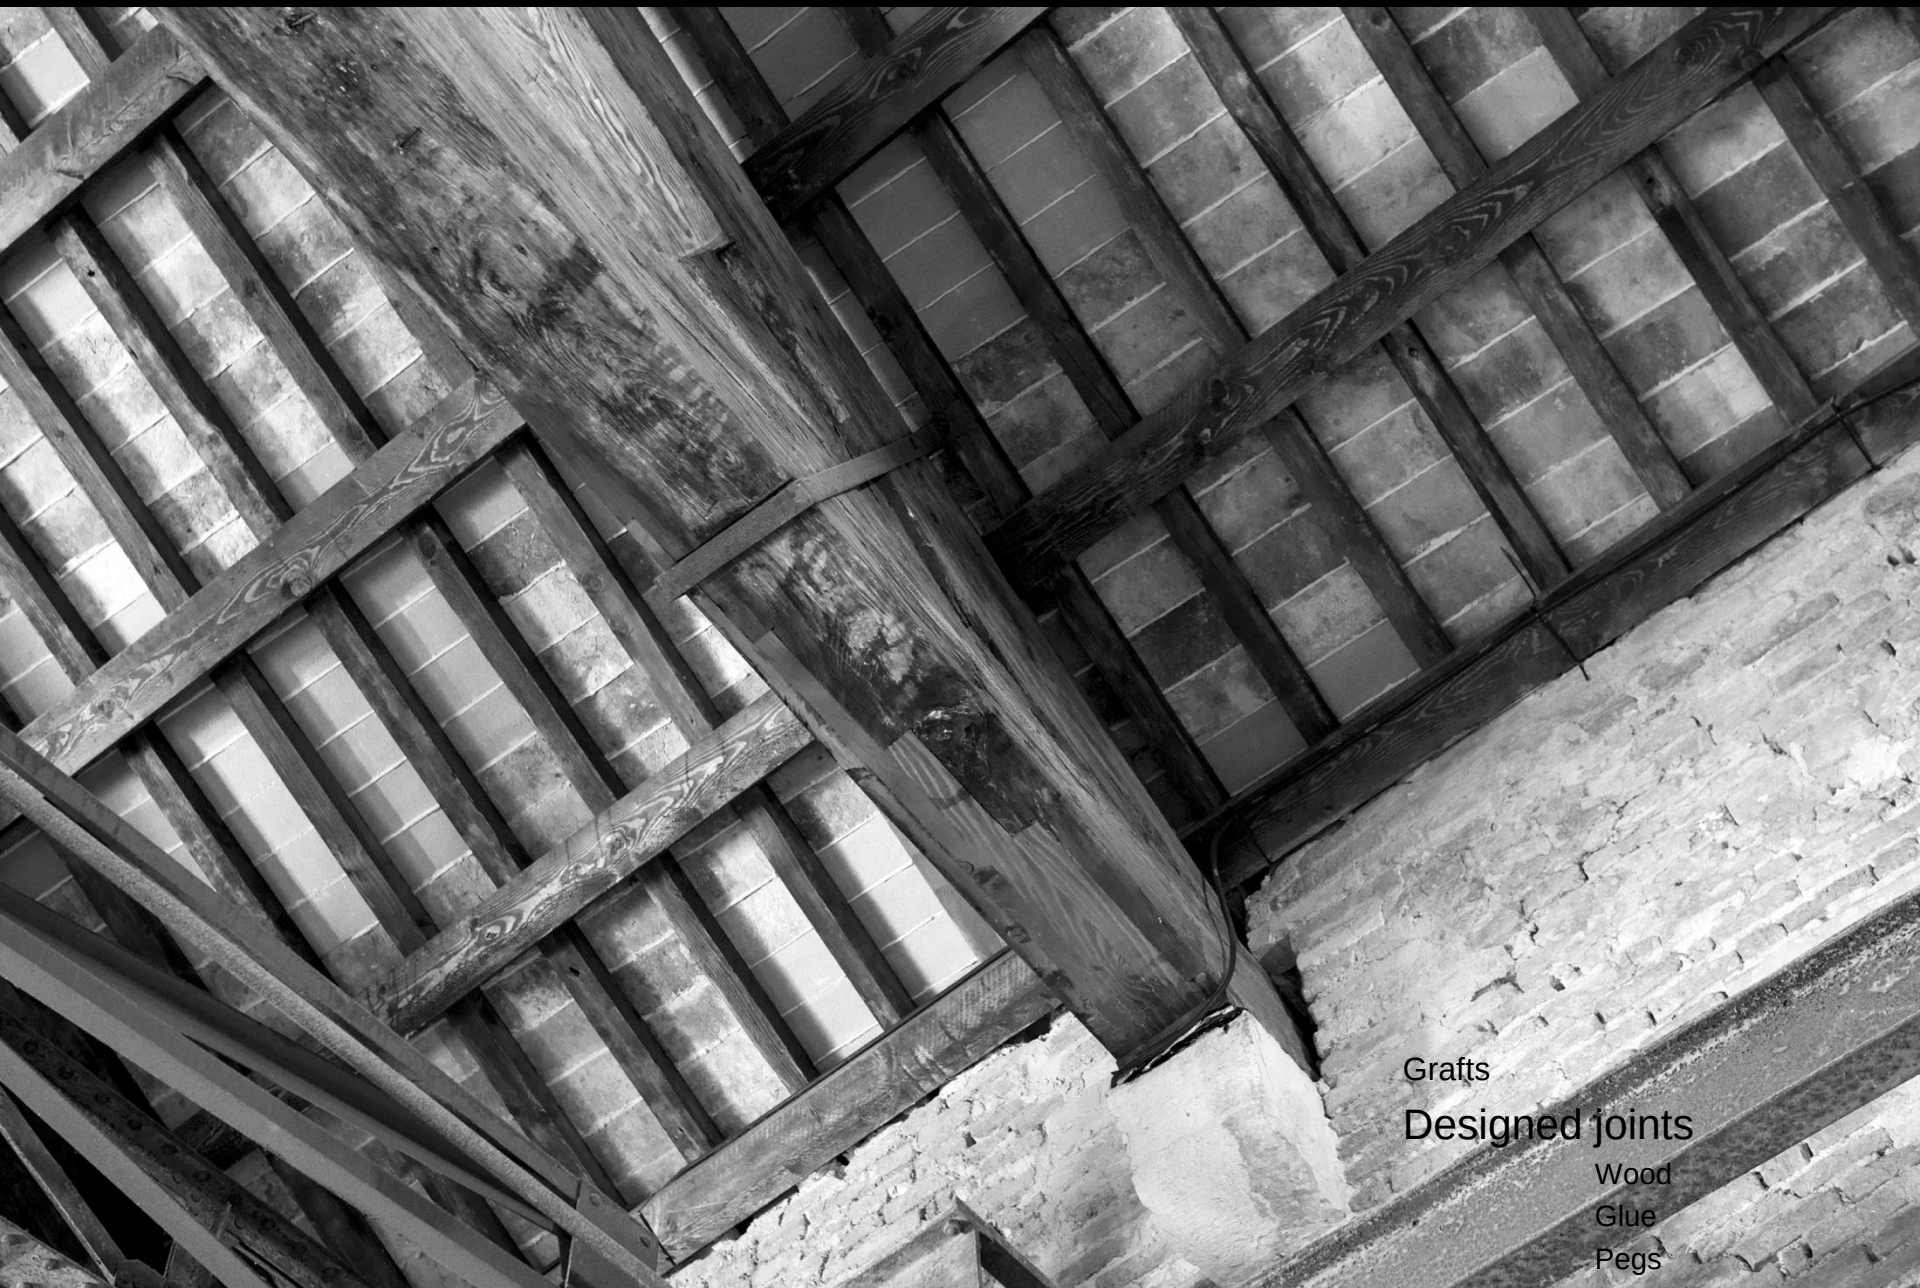
Grafts  
Designed joints  
Wood  
Glue  
Pegs

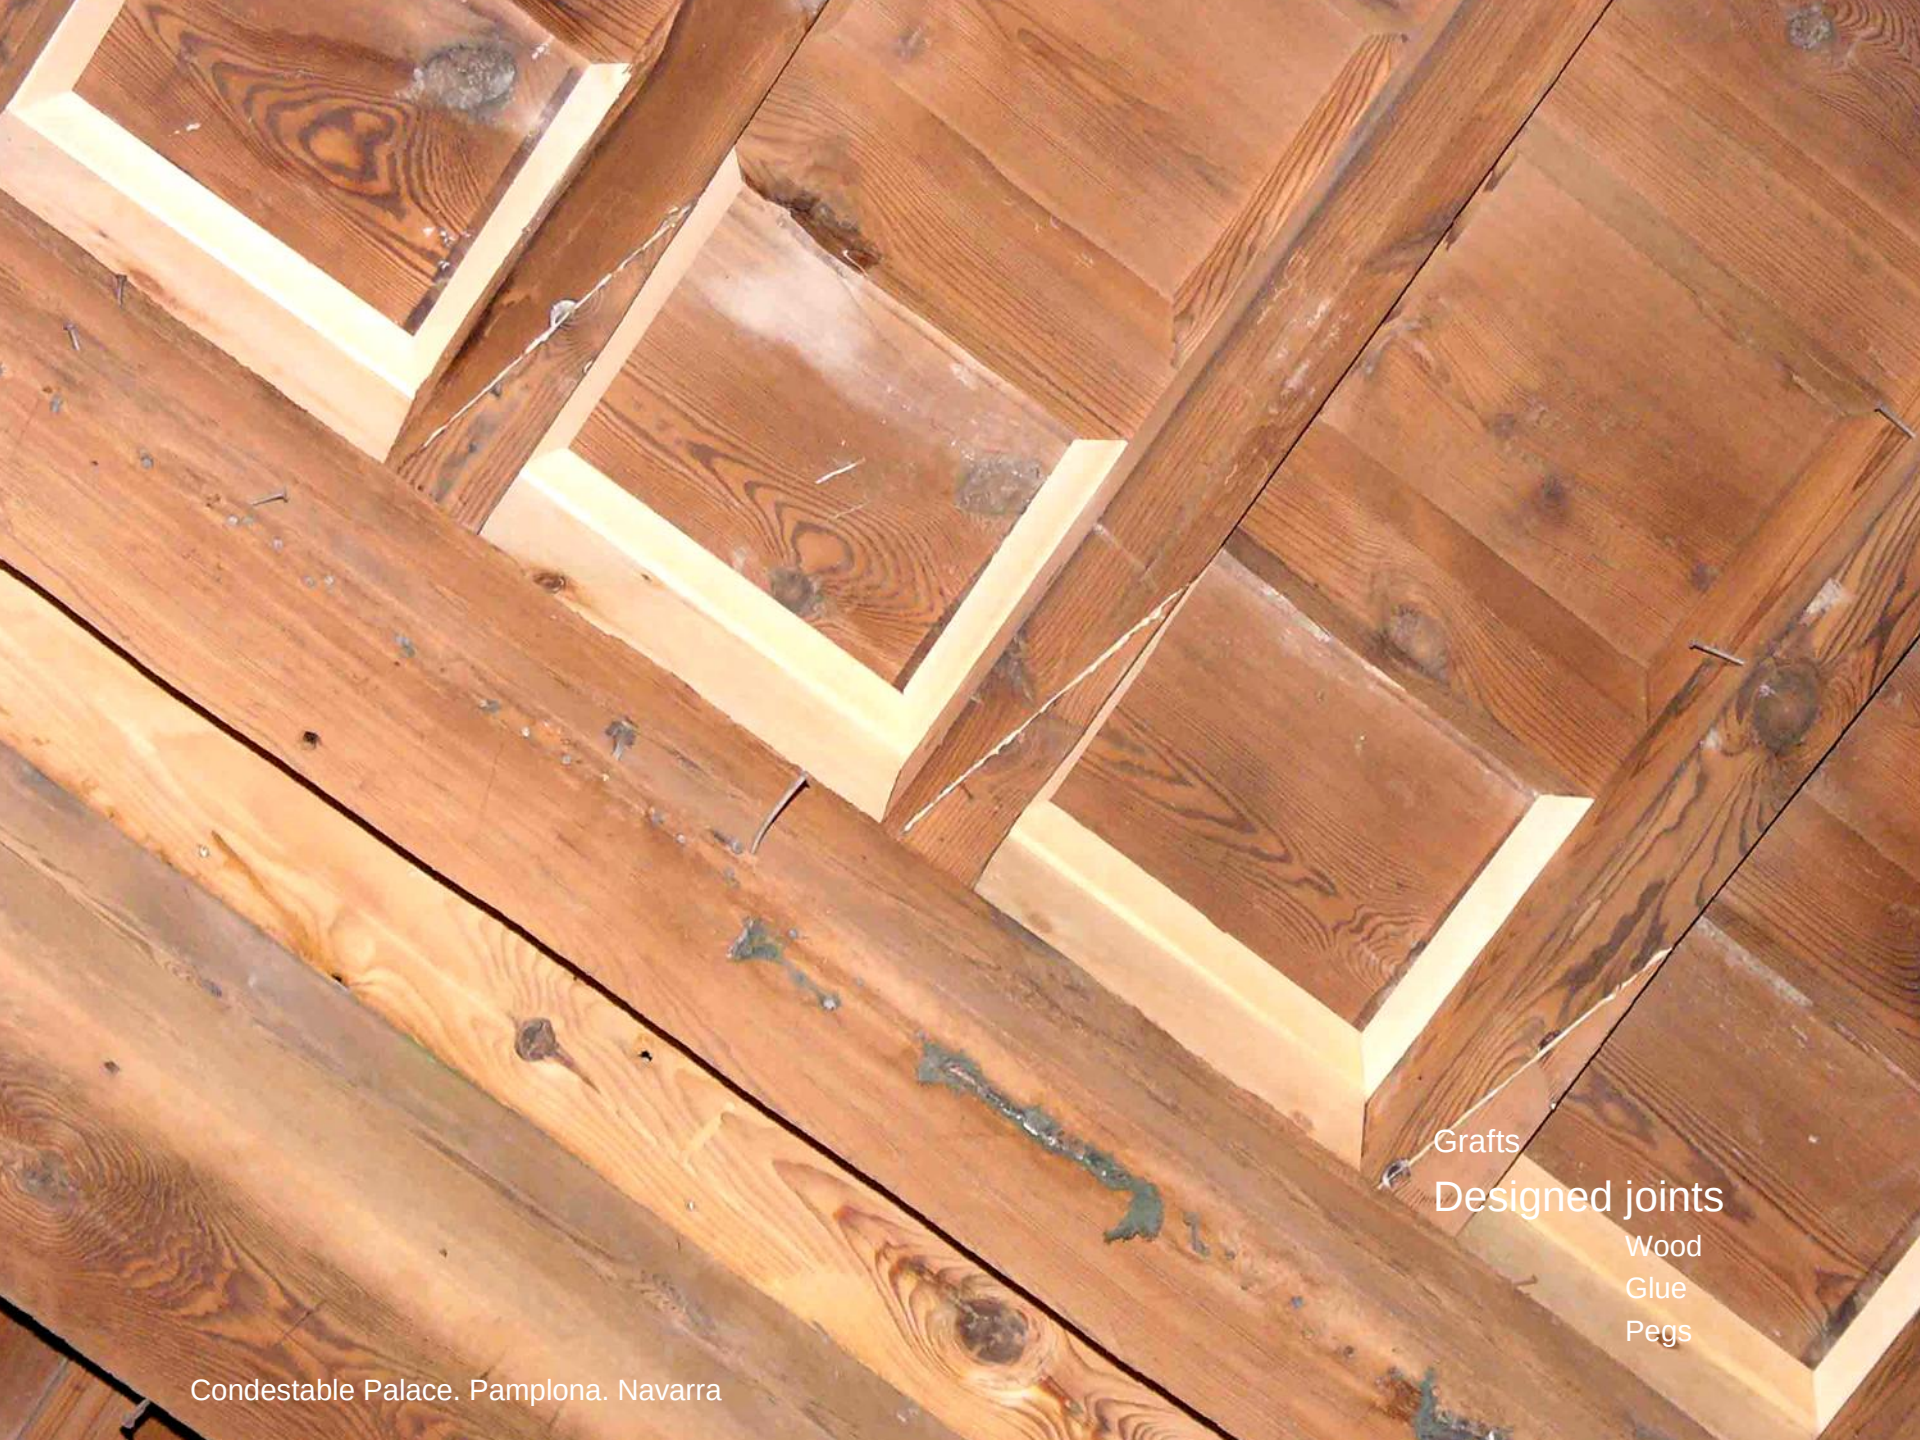
Grafts  
Designed joints  
Wood  
Glue  
Pegs

Condestable Palace. Pamplona. Navarra

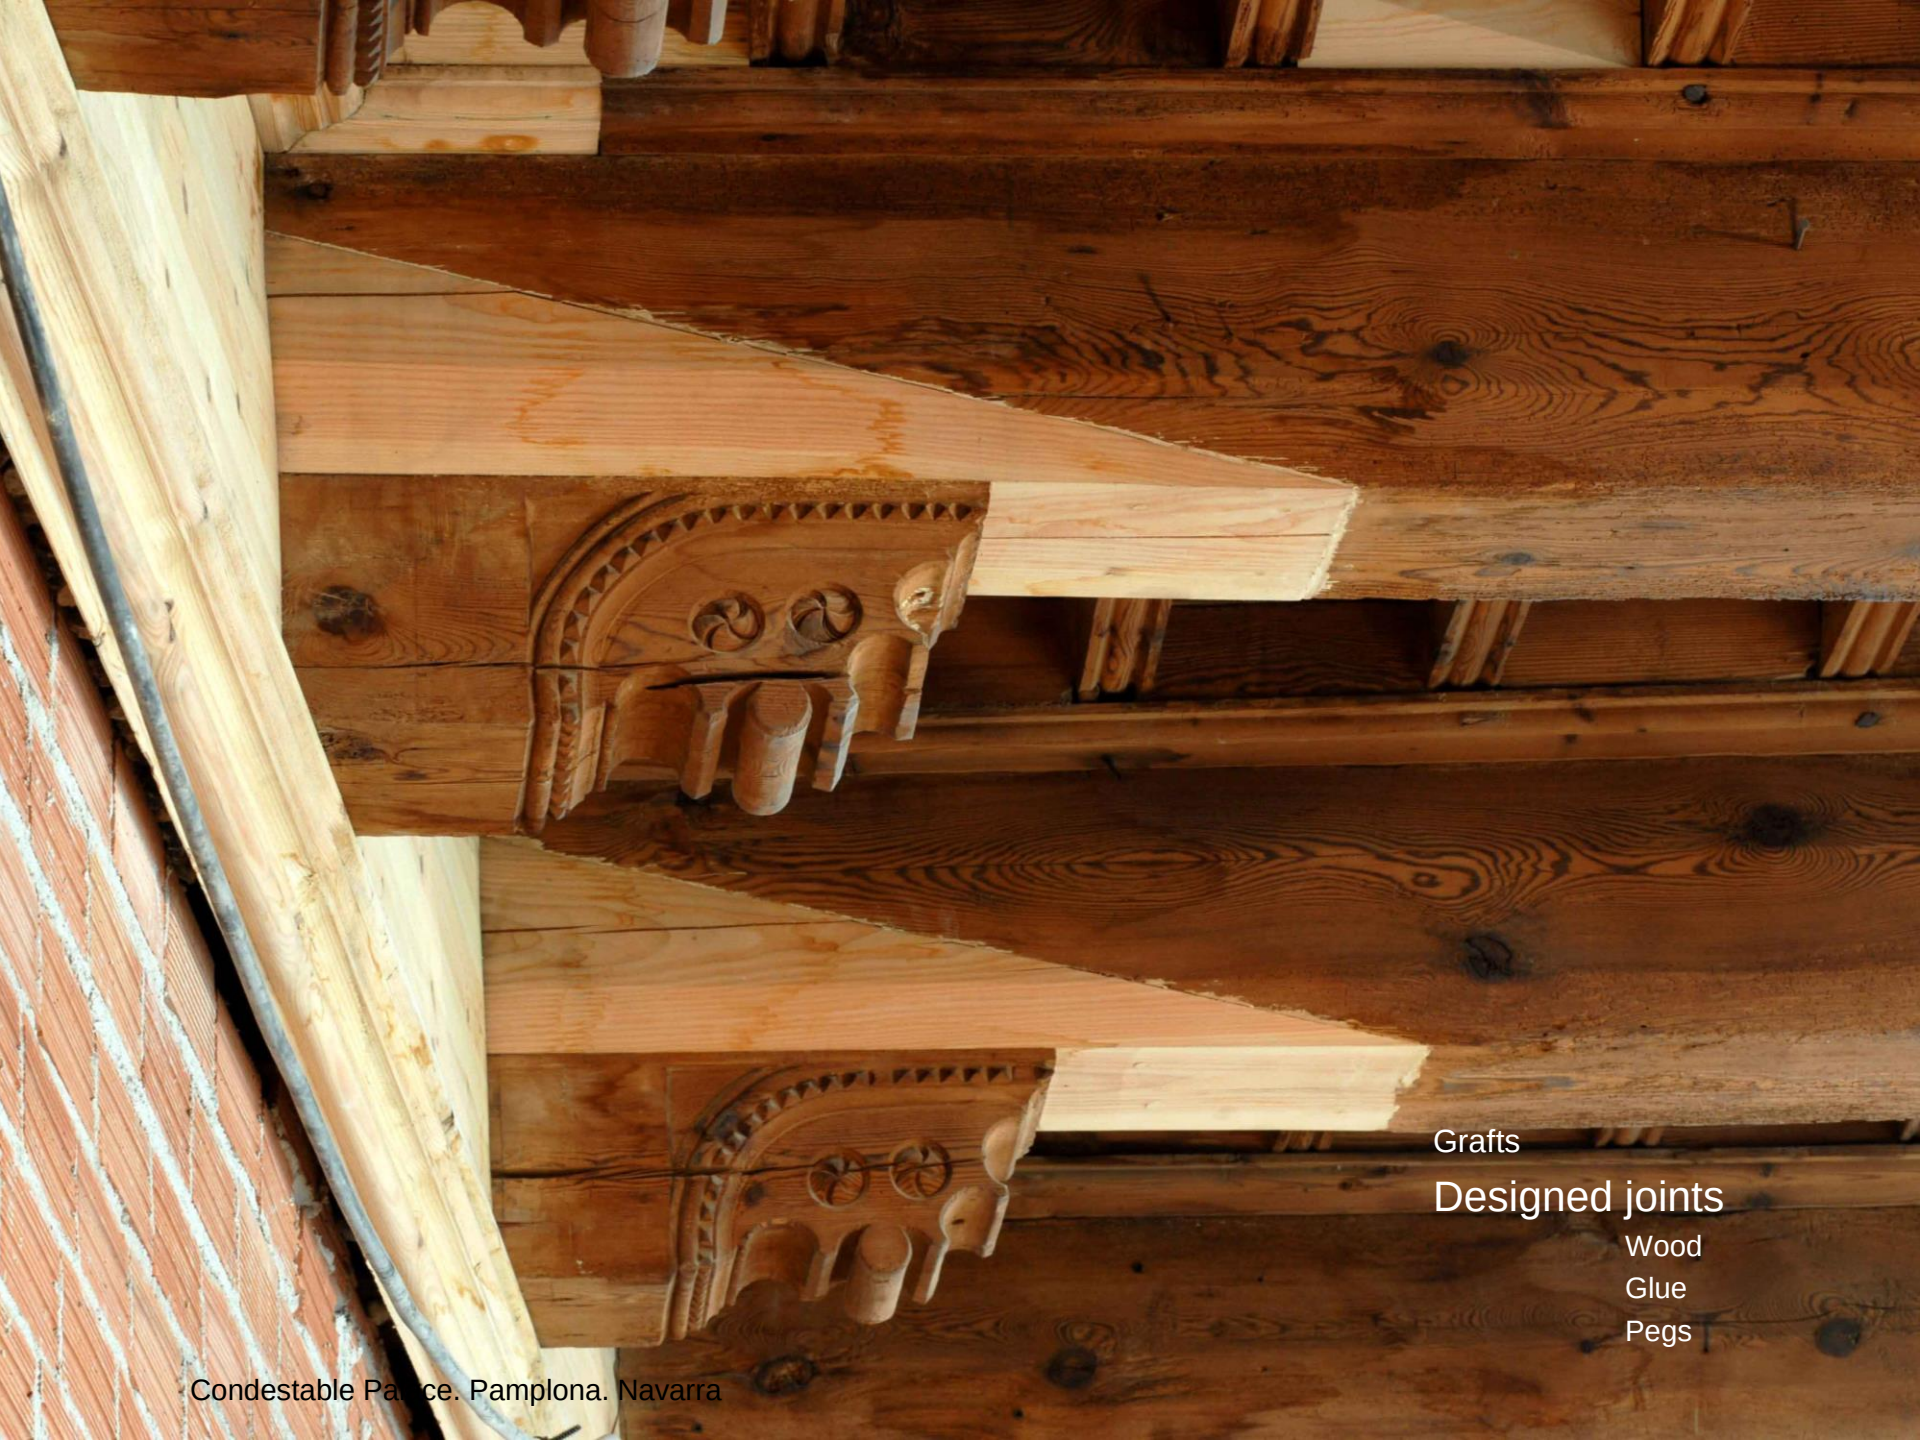
Grafts  
Designed joints  
Wood  
Glue  
Pegs

Condestable Palace. Pamplona. Navarra
