## Systematic approach to preservation of wooden architecture monuments

Petrozavodsk. Russia. September 2016

Minimal intervention and application of technology based on use of wood  
to repair and strengthening of wooden architecture monuments

GPAC Built Heritage Research Group  
landa-ochandiano arquitectos  
Mikel Landa  
Alazne Ochandiano

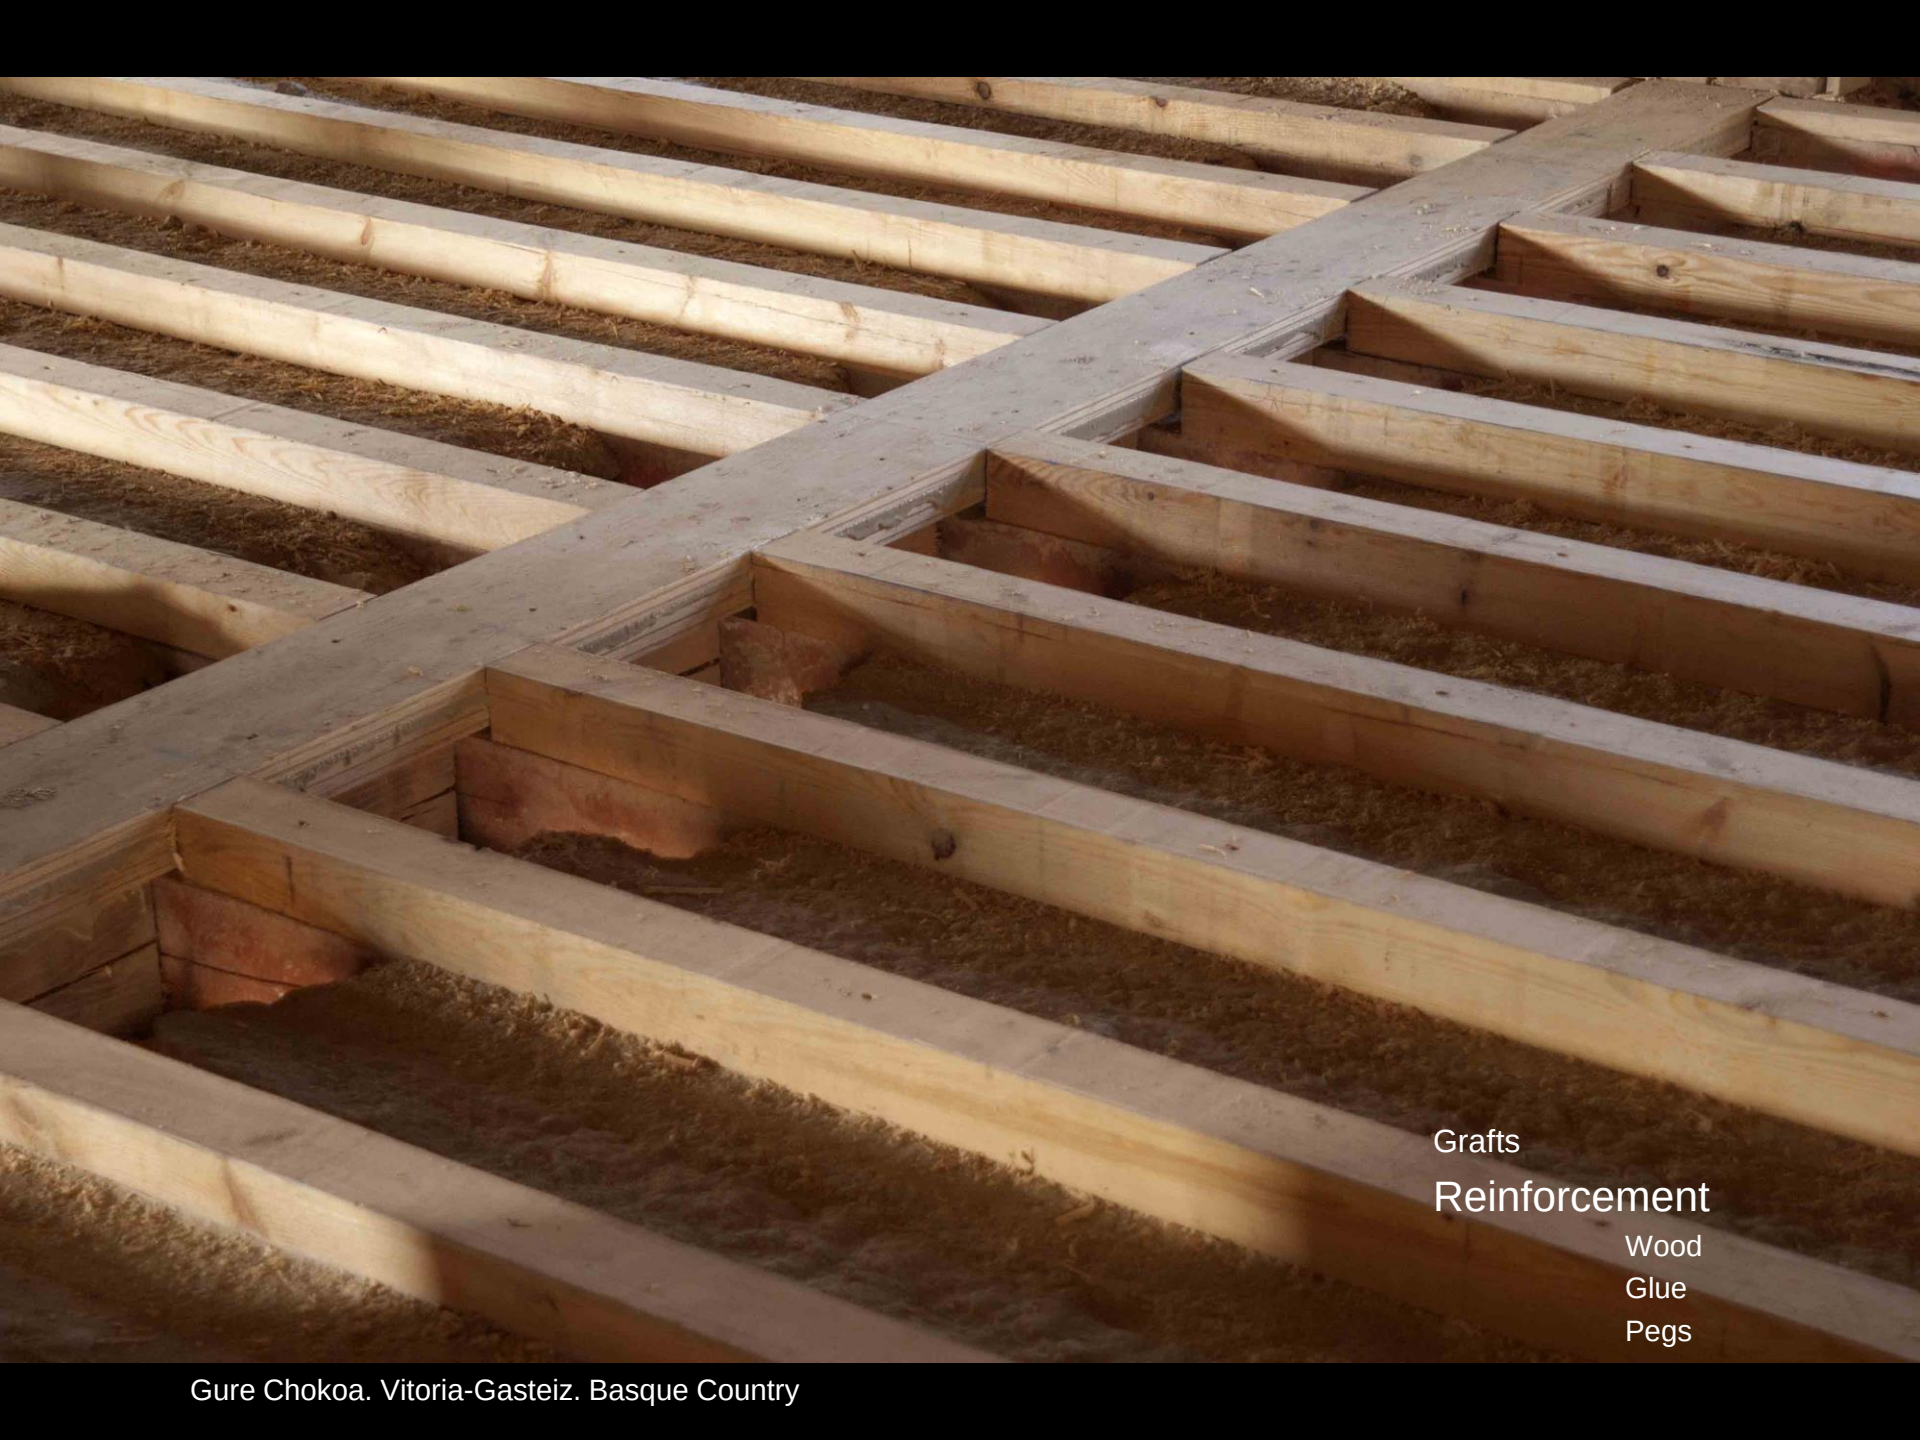
Grafts  
Reinforcement  
Wood  
Glue  
Pegs
